February 2, 2024

Ms. Kim Humphrey
Borough Administrator
Borough of Keyport
70 West Front Street
Keyport, NJ 07735

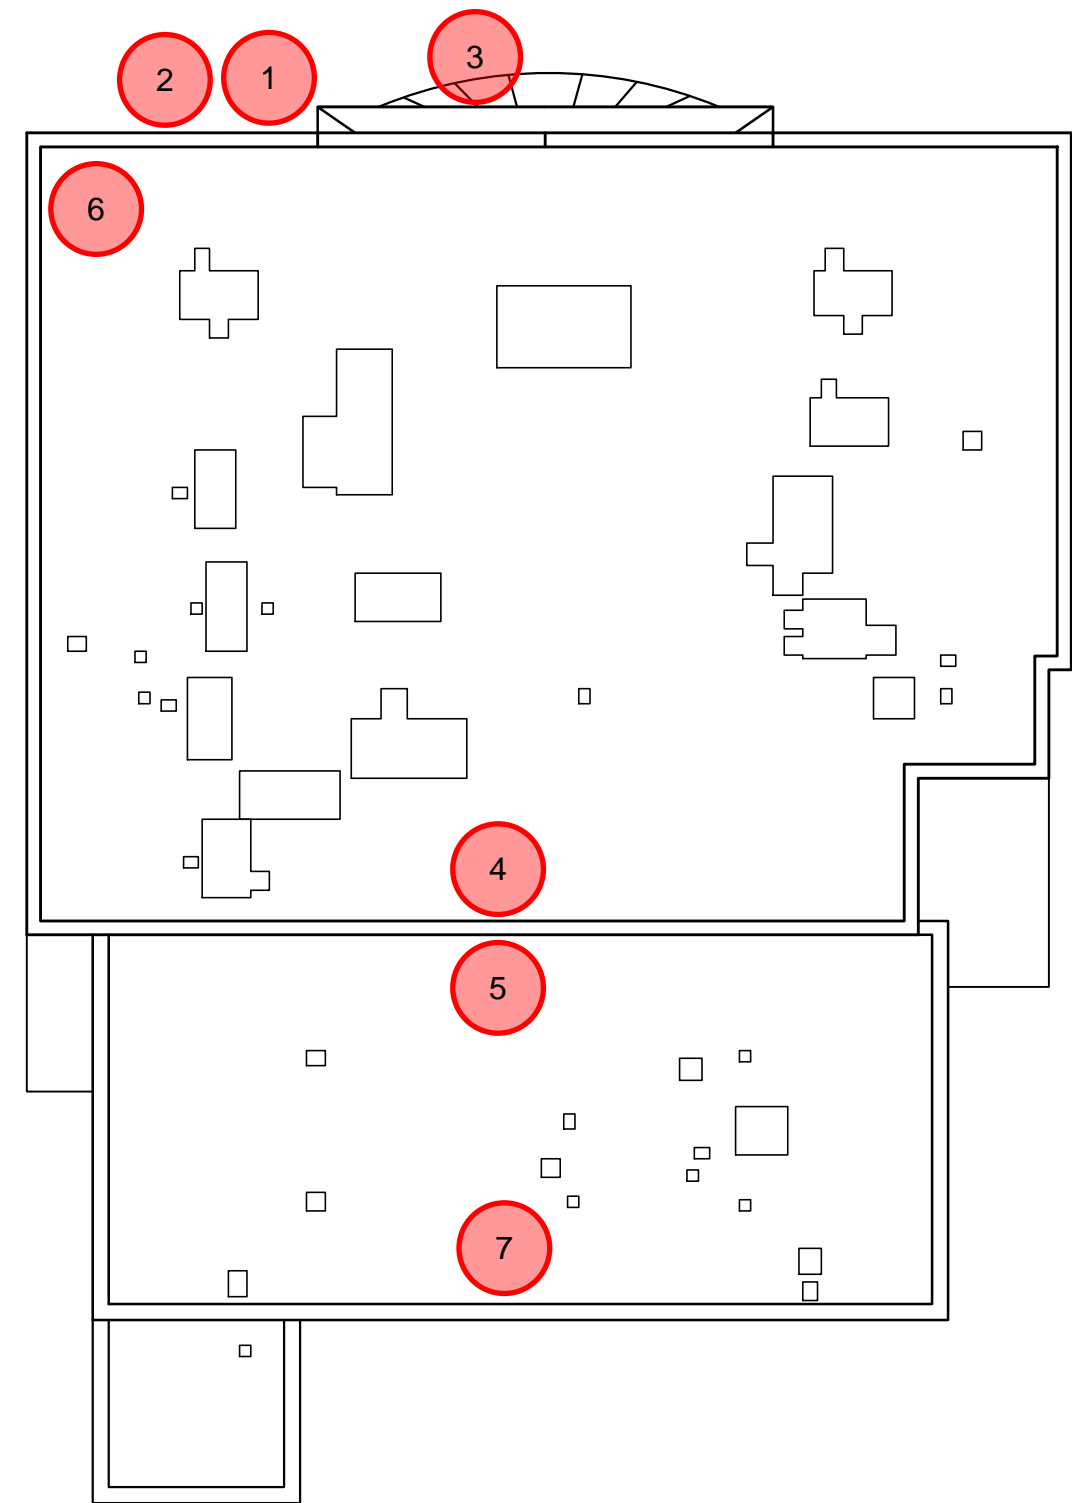
**BOROUGH OF KEYPORT
MUNICIPAL BUILDING
ROOF LEAK INVESTIGATION**

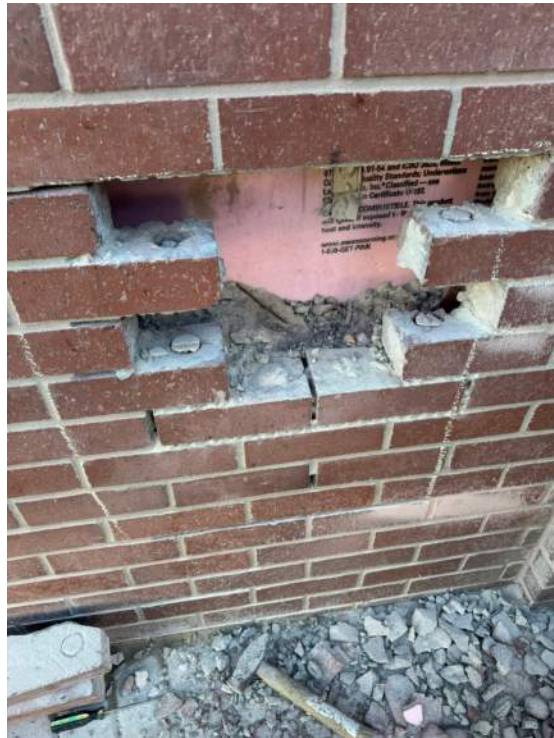
Photo 2 : Probe 1, missing through wall flashing and with cavity filled solid with grout above weep hole.

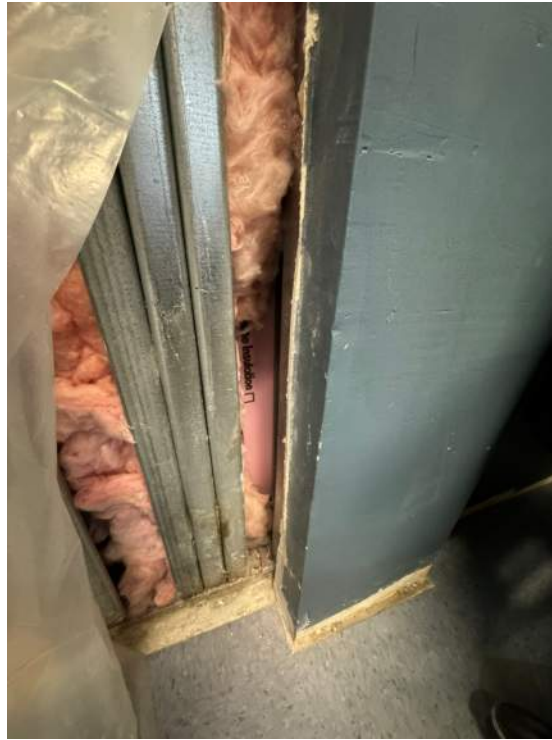
Photo 3 : Probe 1, interior of wall opposite of probe. Completed by others.

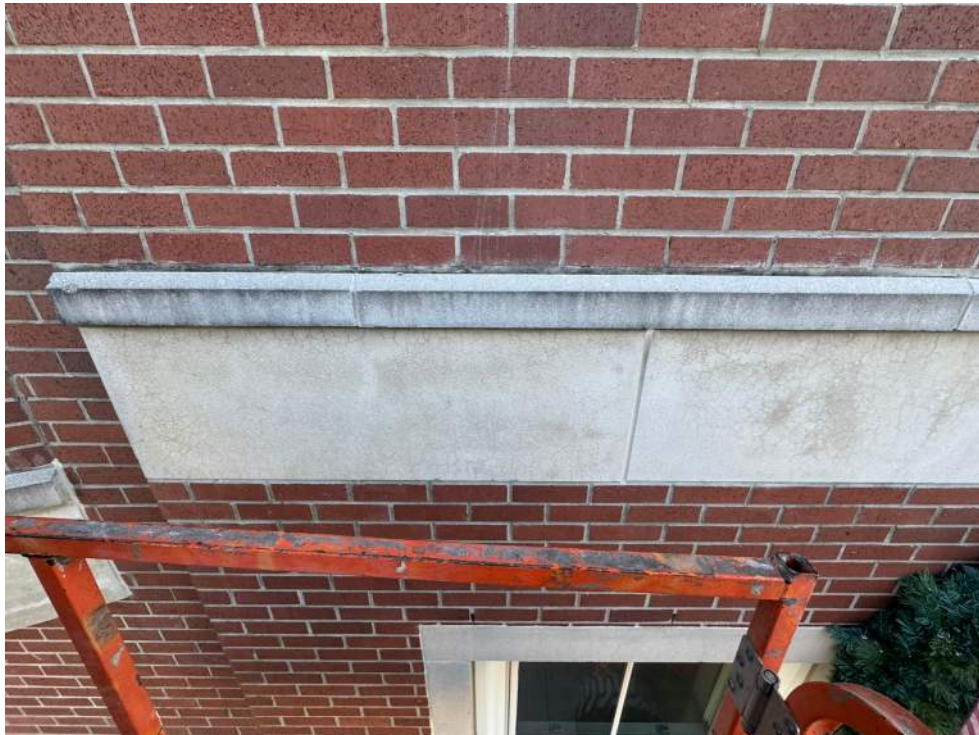
Photo 4 : Missing flashing and weeps holes at material transitions

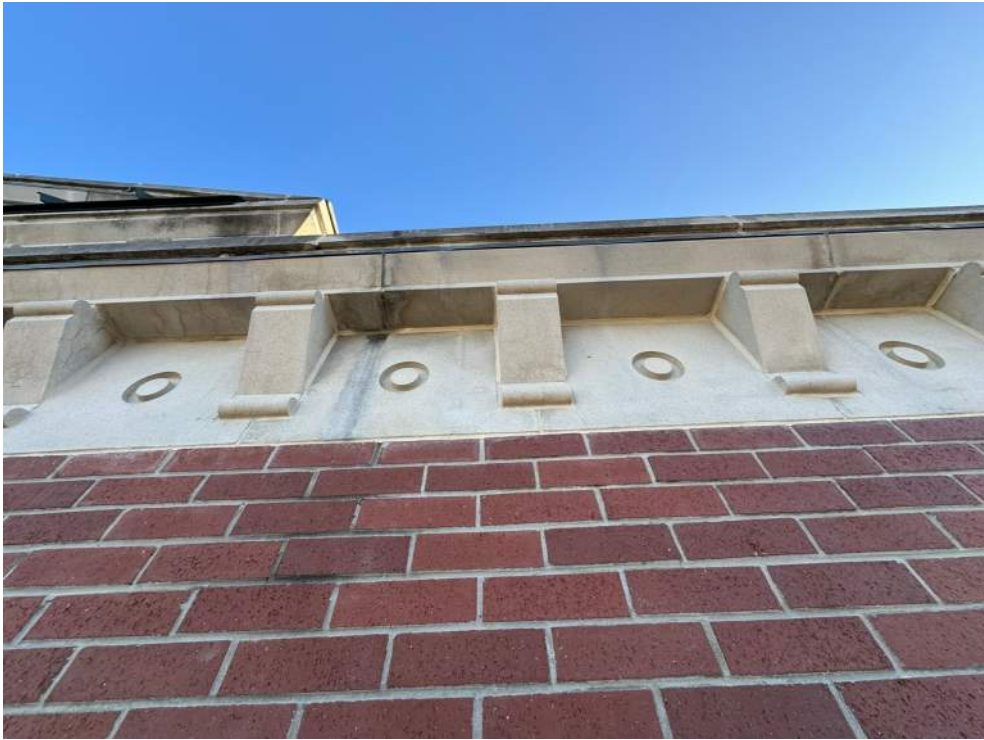
Photo 5 : Missing flashing and weeps holes at material transitions

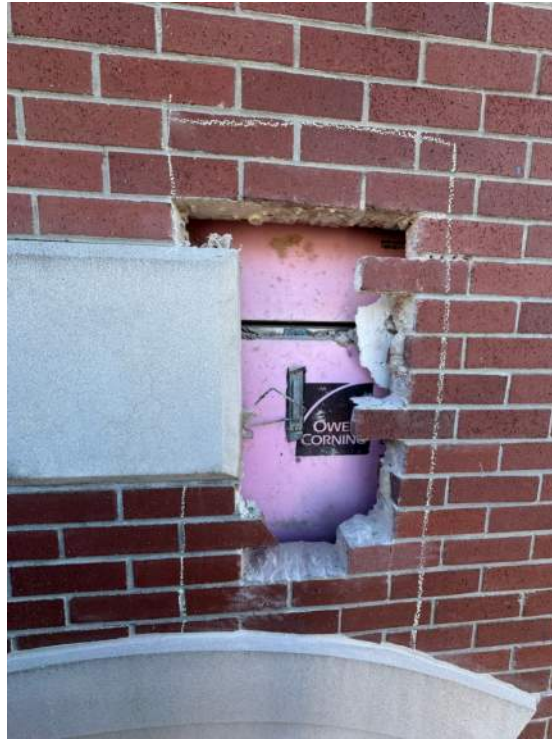
Photo 7 : Probe 2, no flashing or weep holes found.

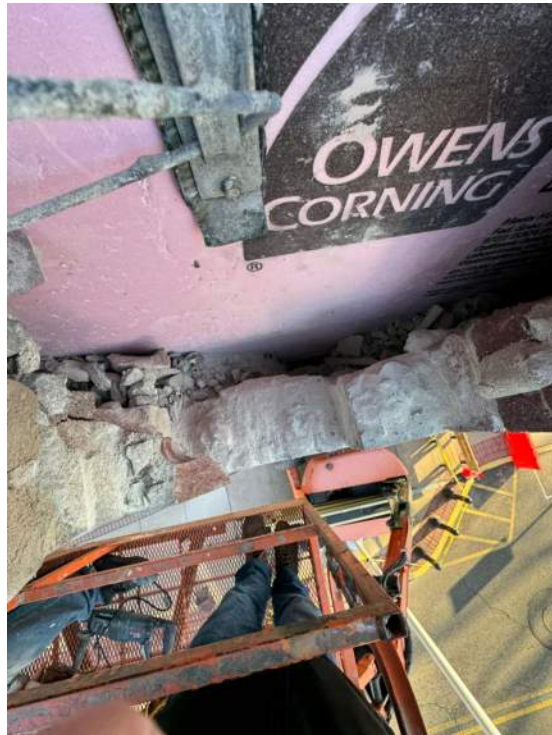
Photo 8 : Probe 2, no flashings or weep holes found looking down cavity to window head.

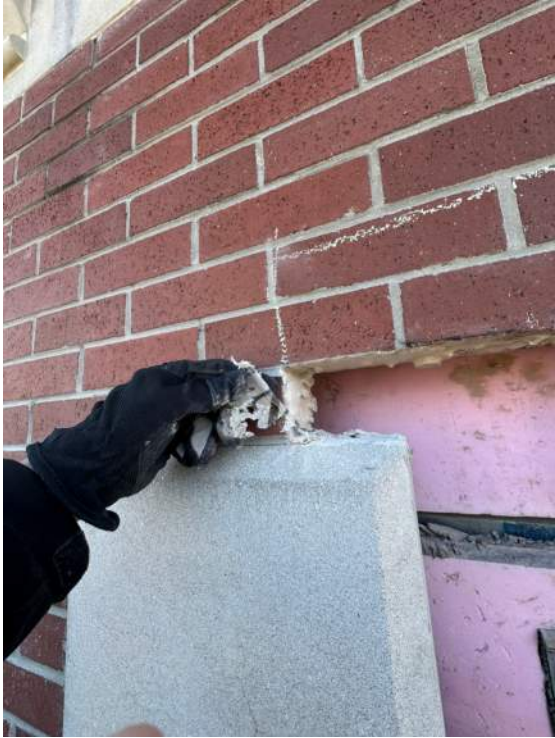
Photo 9 : Probe 2, with foreign body in mortar.

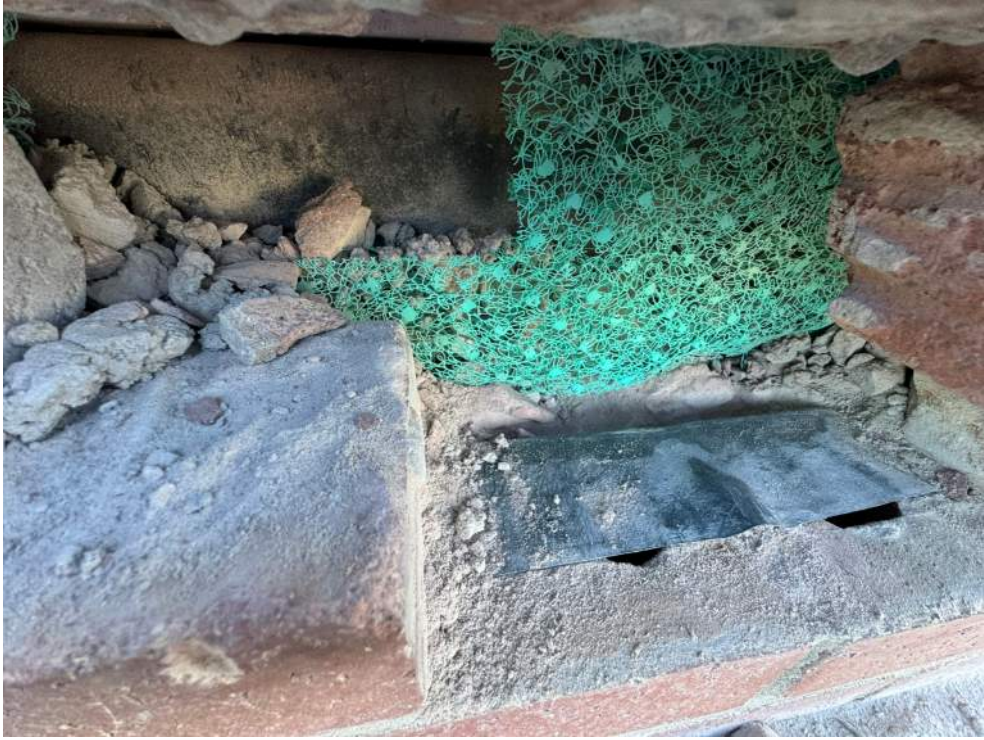
Photo 11 : Probe 3, inverted and inadequate flashing found.

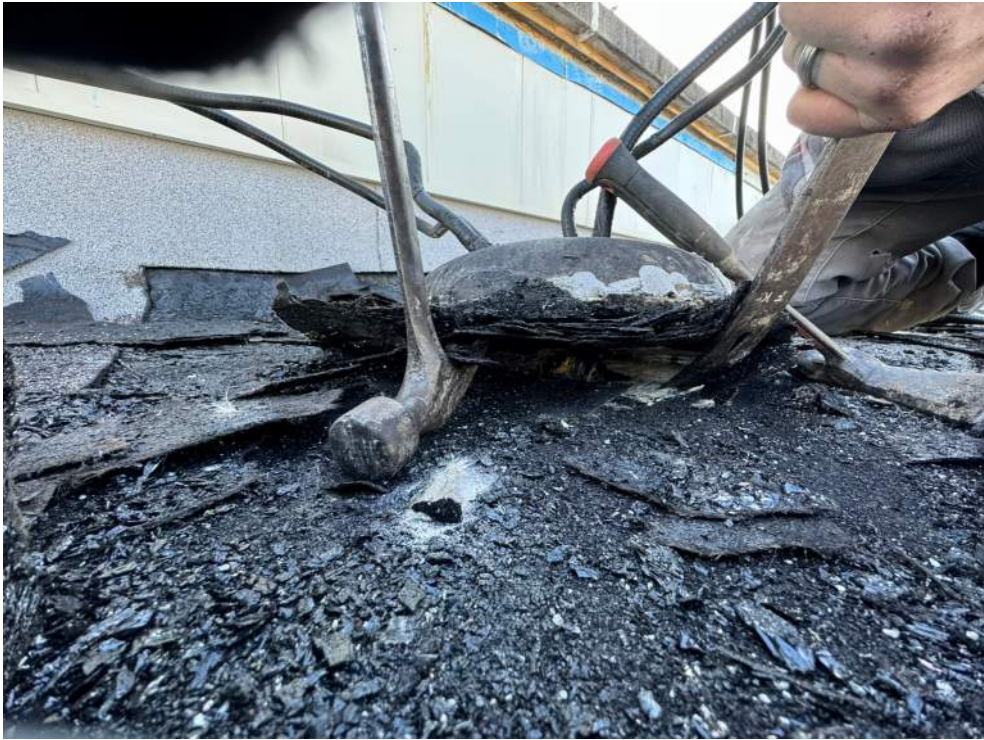
Photo 13 : Probe 4, no flashing found.

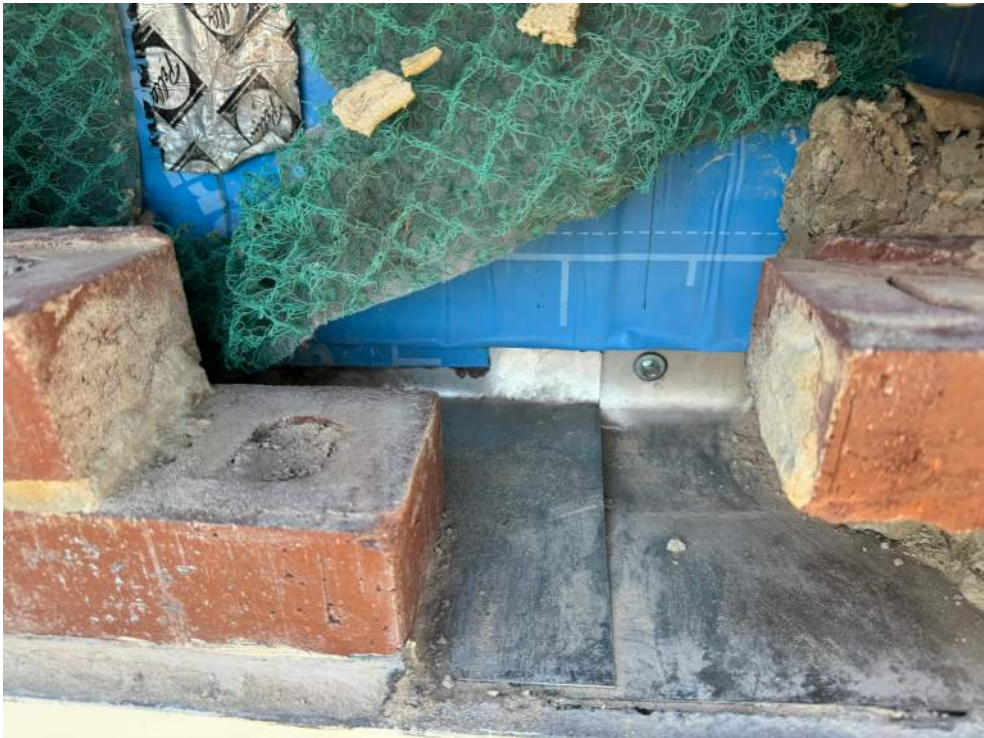
Photo 14 : Probe 5, grout filled cavity and improperly lapped flashing found.

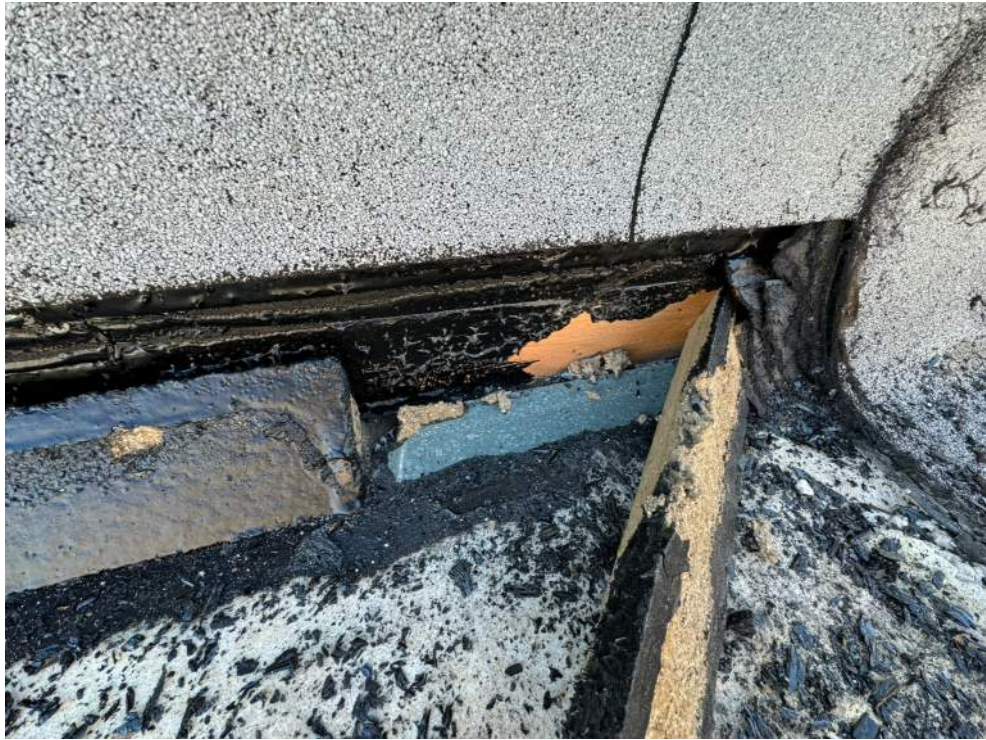
Photo 17 : Probe 7 with dry cant strip found.

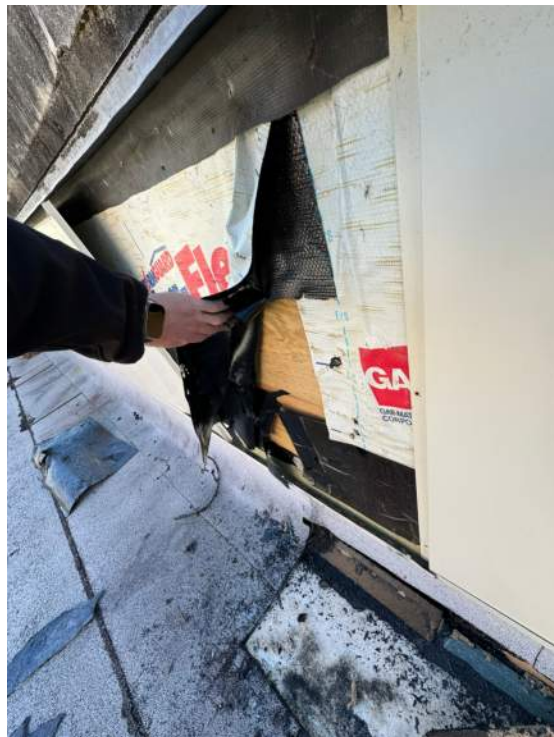
Photo 18 : Probe 7, with dry parapet sheathing found.

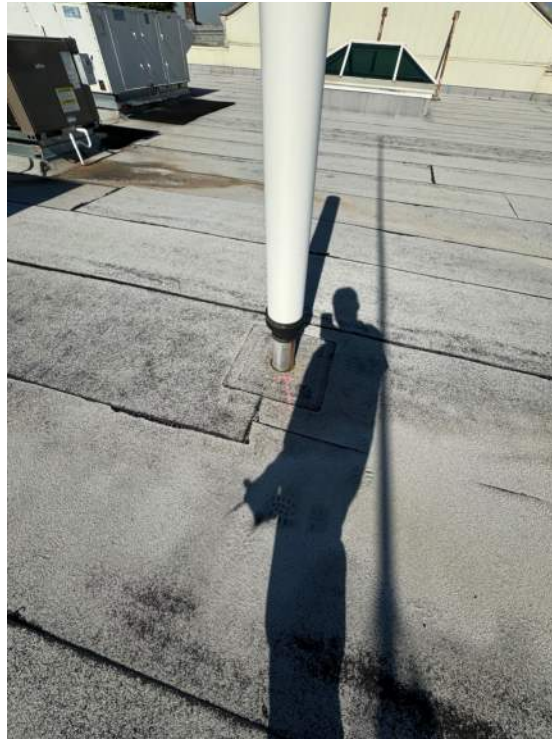
Photo 19 : Inadaquate and missing flashing components found

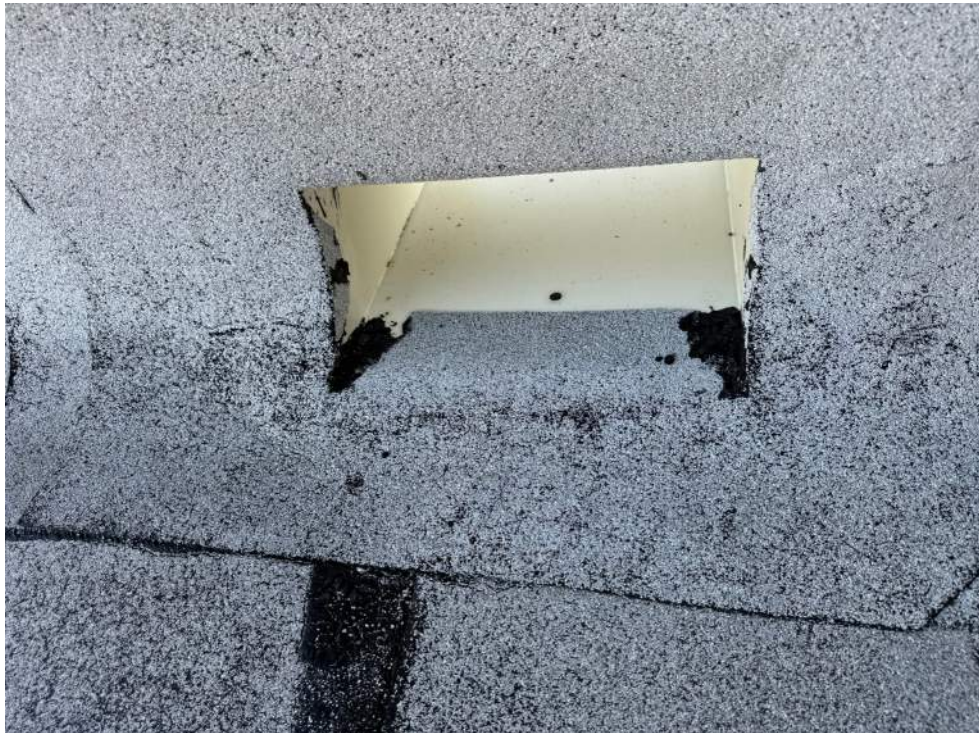
Photo 20 : Inadaquate and missing flashing components found

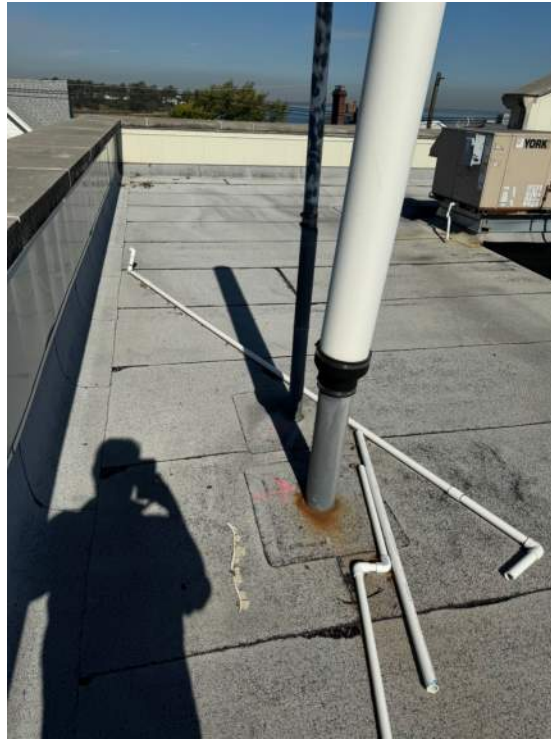
Photo 21 : Inadaquate and missing flashing components found

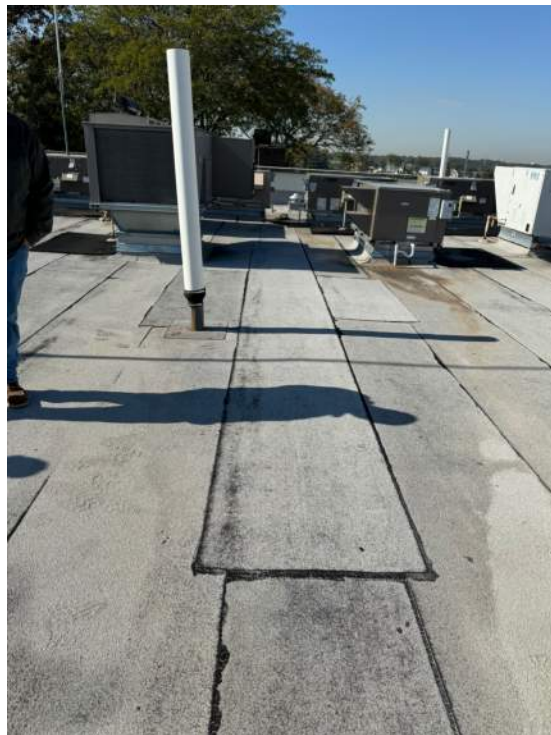
Photo 22 : Improper membrane lapping found.

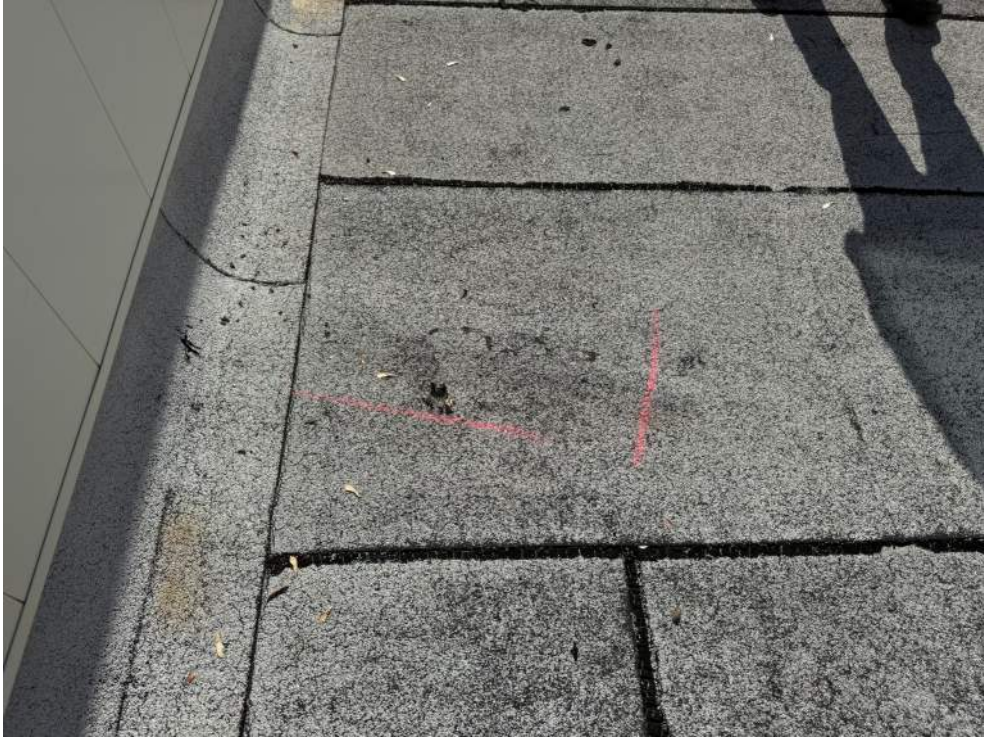
Photo 23 : Delaminating membrane found.

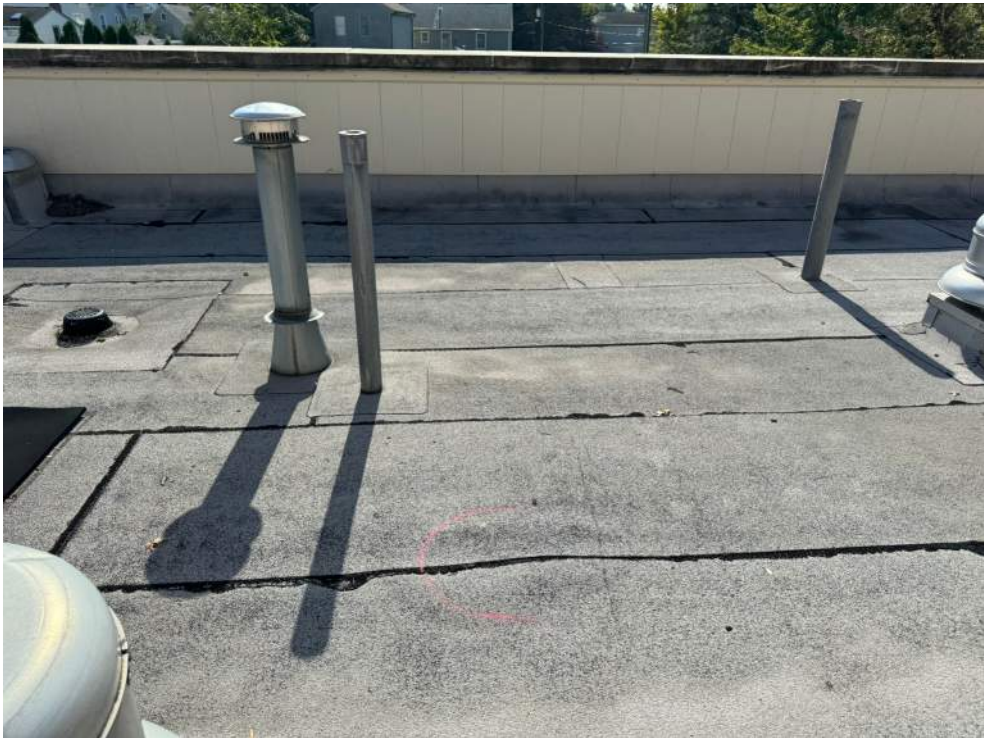
Photo 24 : Delaminating membrane found.

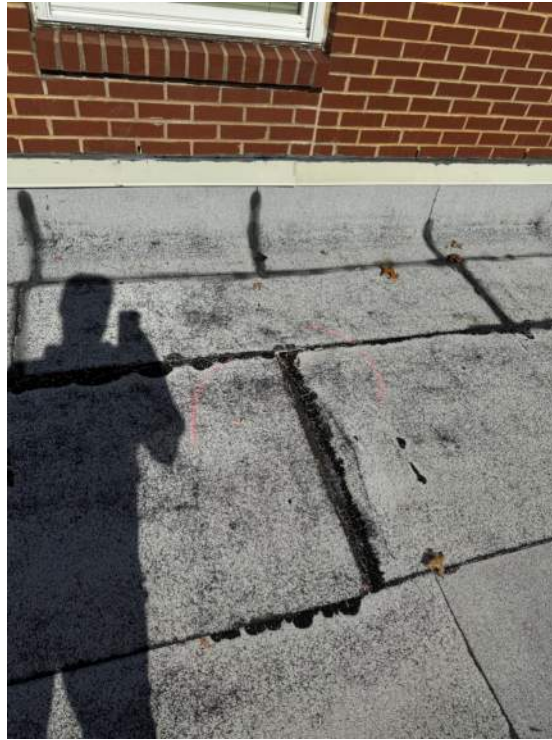
Photo 25 : "Mole Run" in membrane found.

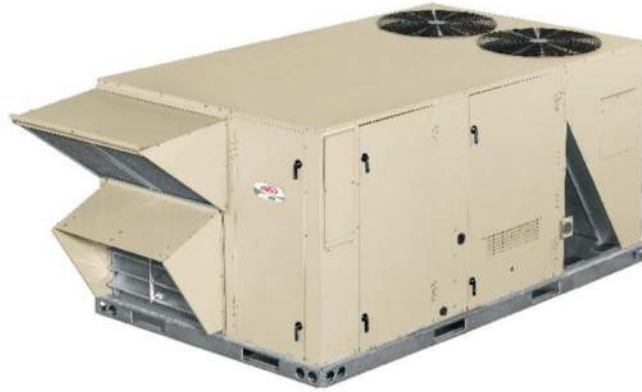
**Roof top units Study for Keyport Municipal Court,
Located at 70 W Front St,
Keyport, NJ 07735.**

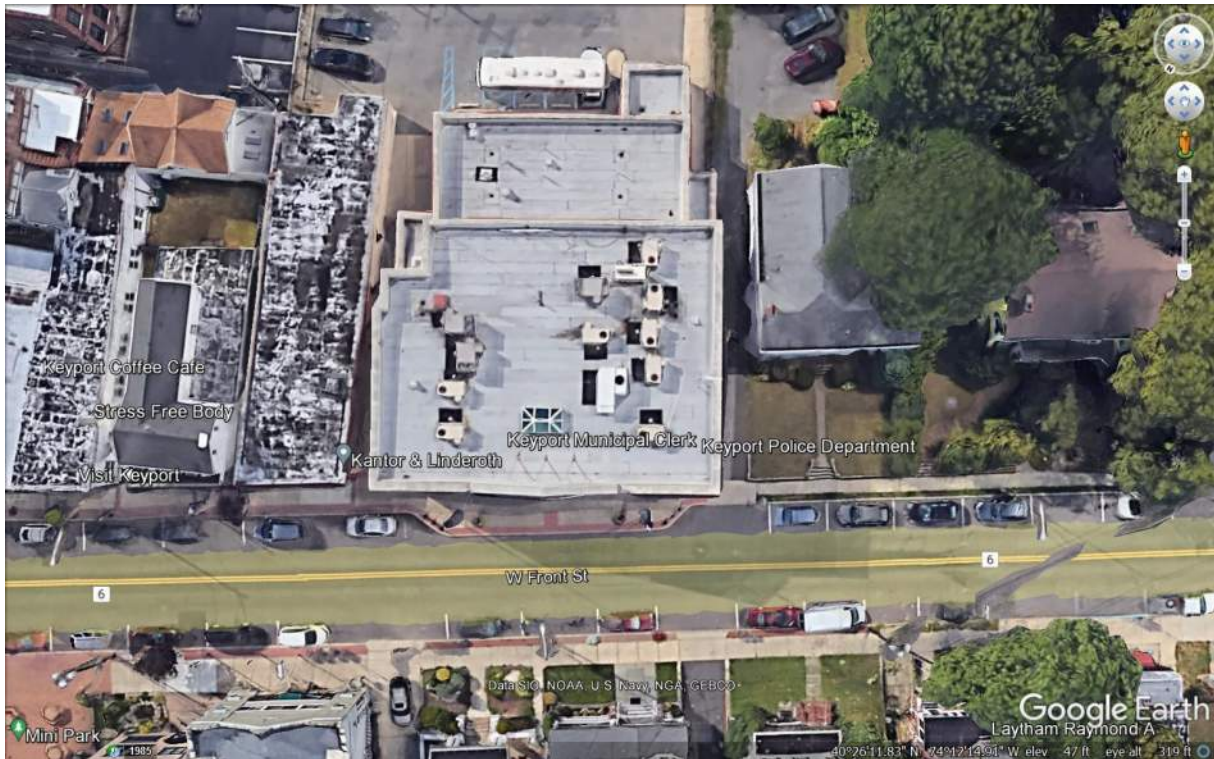
Keyport Municipal Court, Satellite View
