NEW JERSEY DEPARTMENT OF ENVIRONMENTAL PROTECTION
HISTORIC PRESERVATION OFFICE
INDIVIDUAL STRUCTURE SURVEY FORM

HISTORIC SITES INVENTORY NO. 1322-4

LOCATION: 145 Church Street

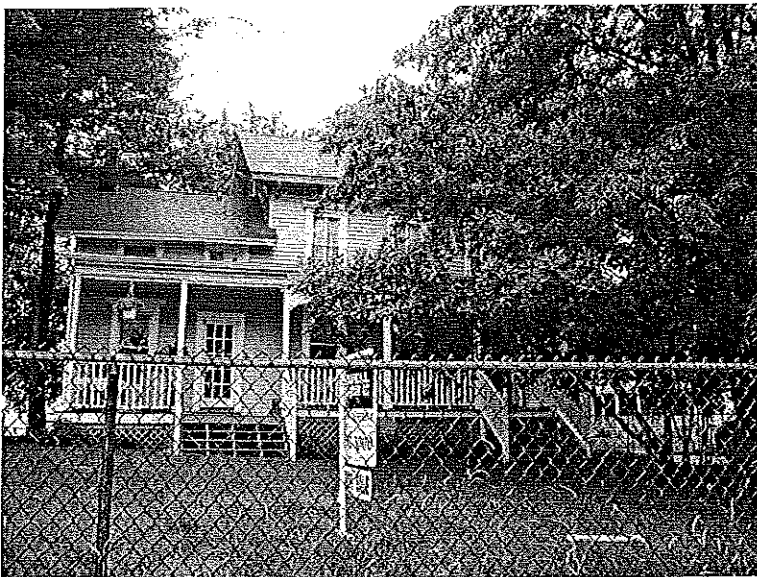
PHOTO Negative File No. 3-10, 11

Elements of Italianate in the paneled frieze, bracketed cornice, 4/4 sash windows with cornices, and heavy punched scroll brackets on porch; two bay kitchen wing is same era as main block; screened porch on south end is later addition.

2006 update: Screened porch now open and part of main porch; vinyl siding covers house.

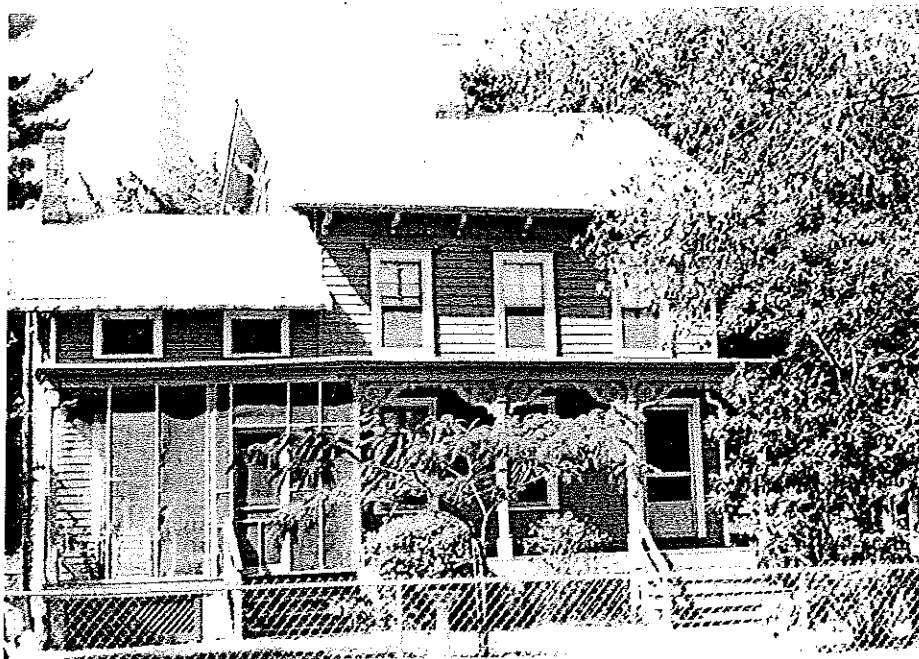
145 Church Street. 1980 photograph.

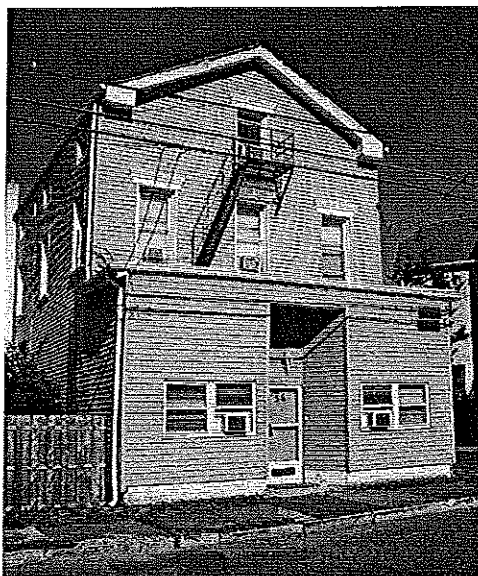
PHOTO Negative File No. 3-25, 26, 27

The first floor front addition, stucco exterior, and the aluminum sided cornice all detract from what was originally a Greek Revival/Italianate building. The wooden window cornices, side door enframement, and segmental arches on side windows remain to indicate former qualities; walls were originally brick.

2006 update: Entire building covered in vinyl siding; new 1/1 sash windows on upper floor.

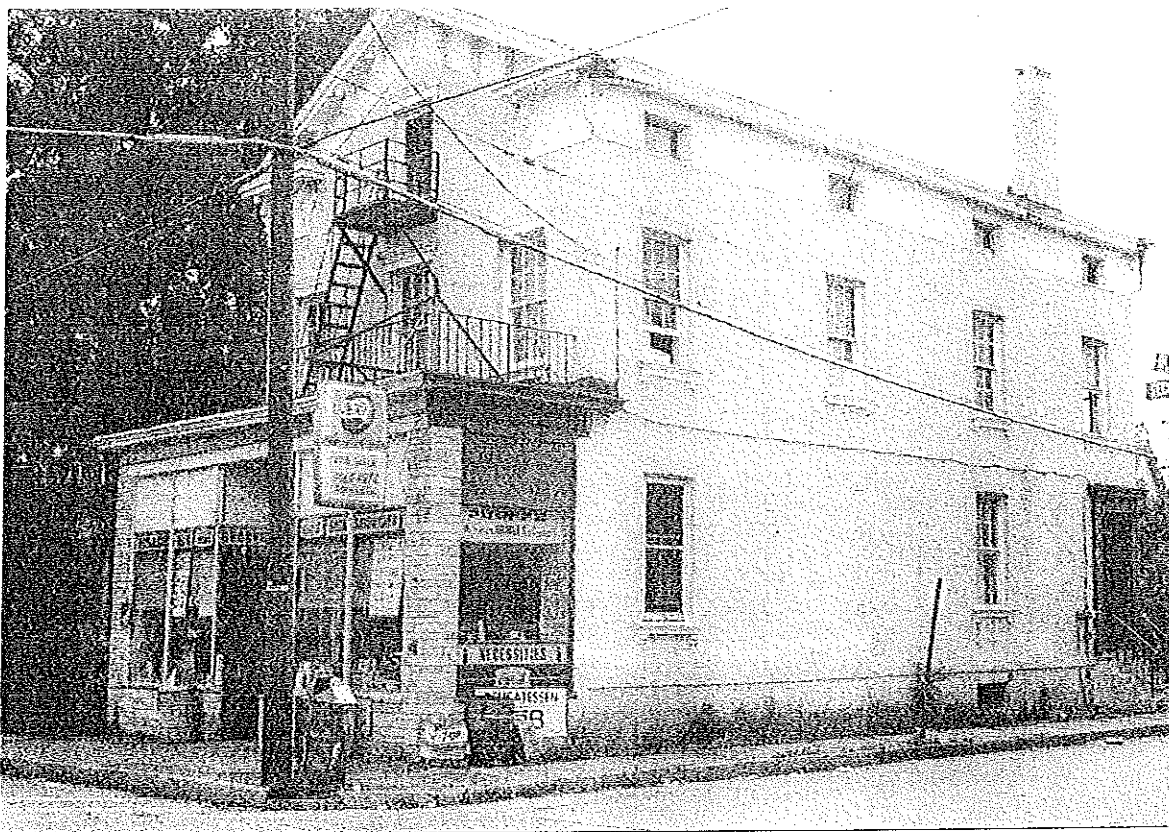
36 Atlantic Street, 1969. Illustrated in Timothy E. Regan, *The American Century Series: Keyport in the Twentieth Century*. Arcadia, 1998. p.90.

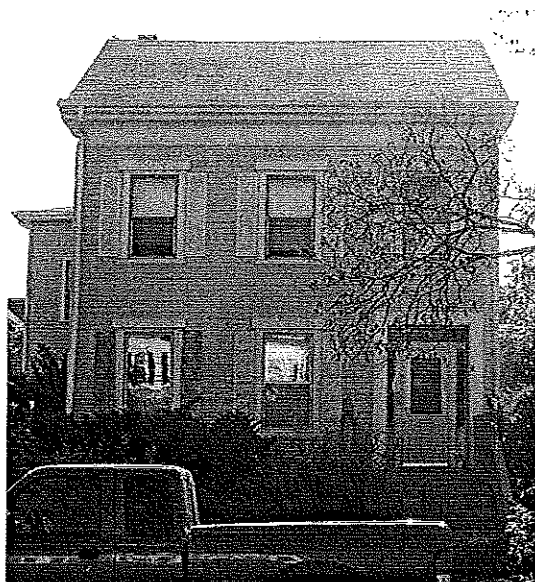
PHOTO Negative File No. 3-22

Greek Revival features include box cornice, plain frieze on main facade, and pilastered entry with transom and sidelights; Asbestos shingles cover original clapboard exterior; 1/1 sash windows and glass-paned door are 20th C. alterations. See also 43 Atlantic Street (1322-7).

2006 update: Covered in vinyl siding; new window encasements with synthetic lintels and sills; shutters added; wooden staricase looks like a recent addition.

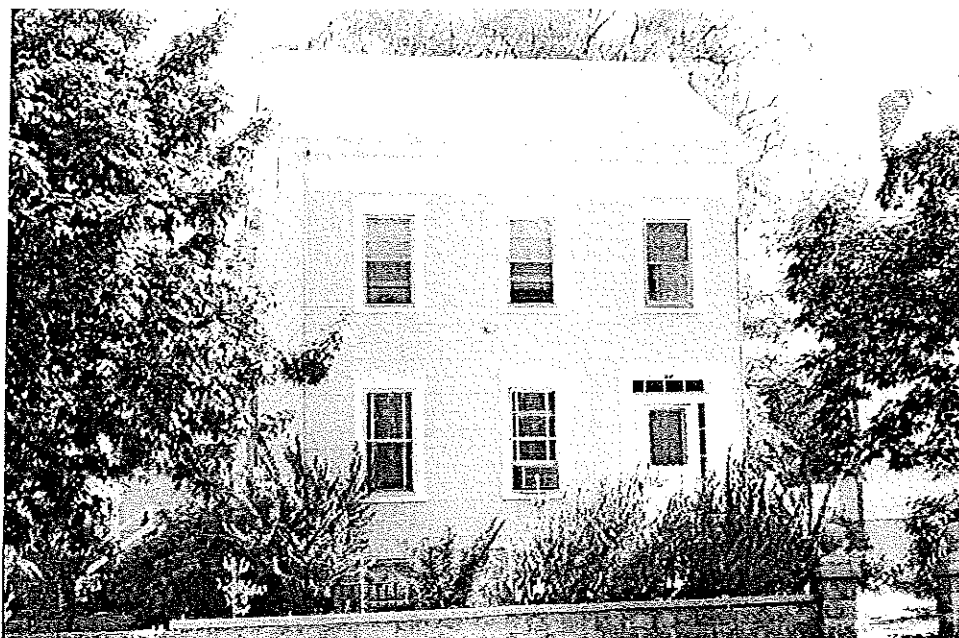
41 Atlantic Street. 1980 photograph.

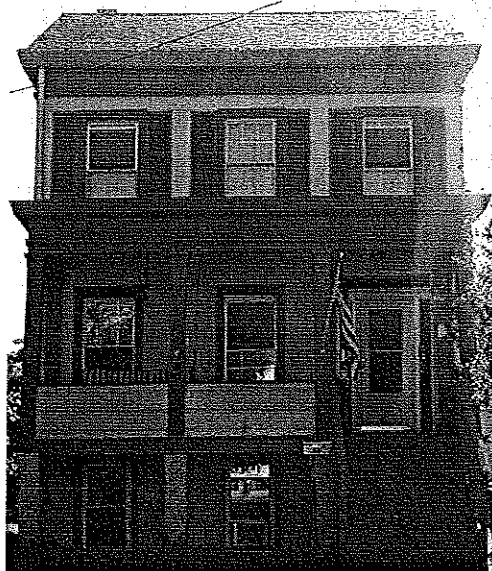
PHOTO Negative File No. 3-23, 24

Greek Revival features include box cornice, plain frieze on main facade, and pilastered entry with transom and sidelights; asbestos shingles cover original clapboard exterior; scalloped storm door is 20th C. addition. See also 41 Atlantic Street (1322-6).

2006 update: New 20th C. storm door.

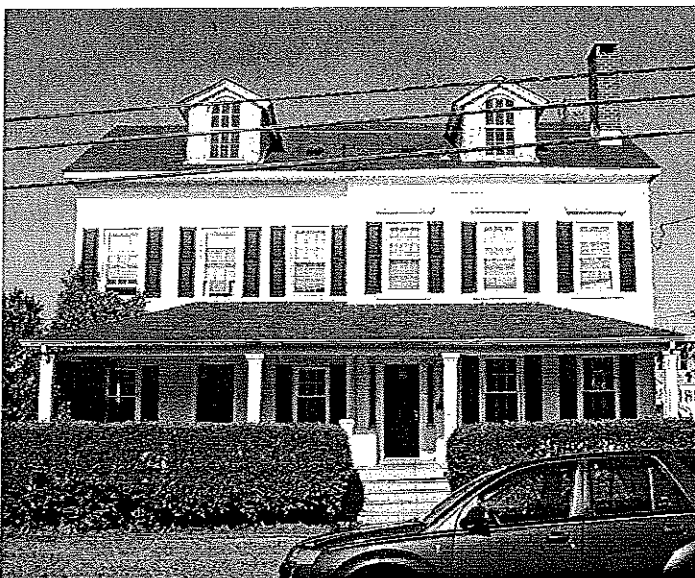
PHOTO Negative File No. 3-18, 19, 20, 21, 8-21

House was built in two 3-bay sections; the original Greek Revival house (north end) features a wide frieze, 6/6 sash windows with prominent cornices, pilastered entry with slender 2/3 sidelights; late 19th C. additions include 3-bay south wing, round arch Italianate dormers, and full porch with square posts. Retains much of the original interior woodwork, including stairway, balustrade, wainscoting, door frames, and molding.

2006 update: Downspouts on facade have been removed; front end chimney has been replaced but remains in the same position; round arch windows have been replaced with non-conforming 6/6 sash windows.

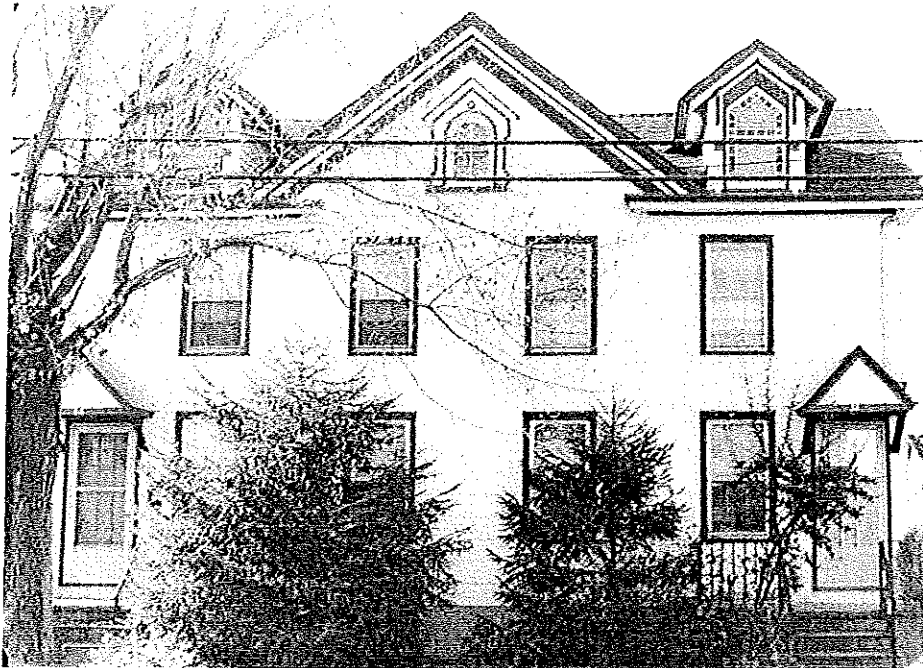
52-54 Atlantic Street. 1980 photograph.

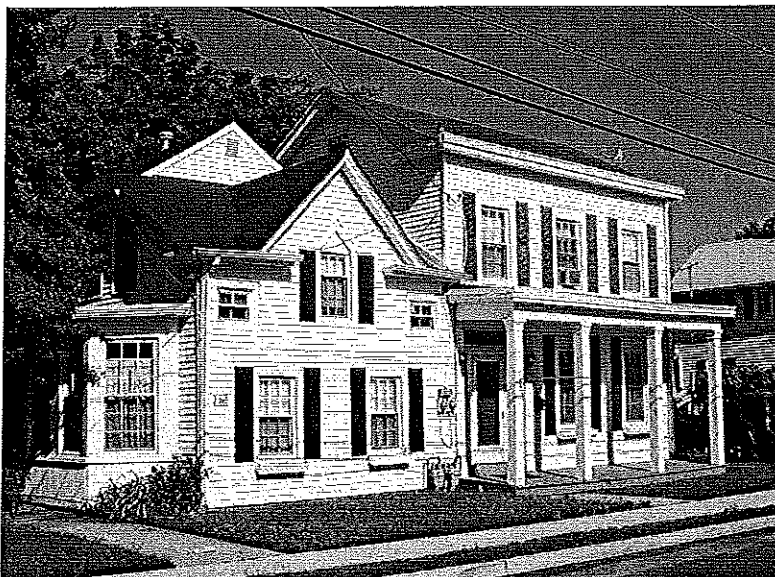
PHOTO Negative File No. 3-16

Extensive modifications, the most recent being aluminum siding and smaller windows (note enframements), which have obliterated most detailing; remaining early features include the original Greek Revival entry, with transom and sidelight; and the 3-bay porch with square posts; the curious south wing is a composite, exhibiting Victorian elements such as a pointed arch window, projecting bay, and steep pitched cross gable roof.

2006 update: Facade remains the same but a large L-plan addition with a porch has been added at the SW end of the house. It appears to have been added on as part of the first wing, as the chimneys were removed and the back of the wing was raised to 2 stories. All windows have 6/6 sash.

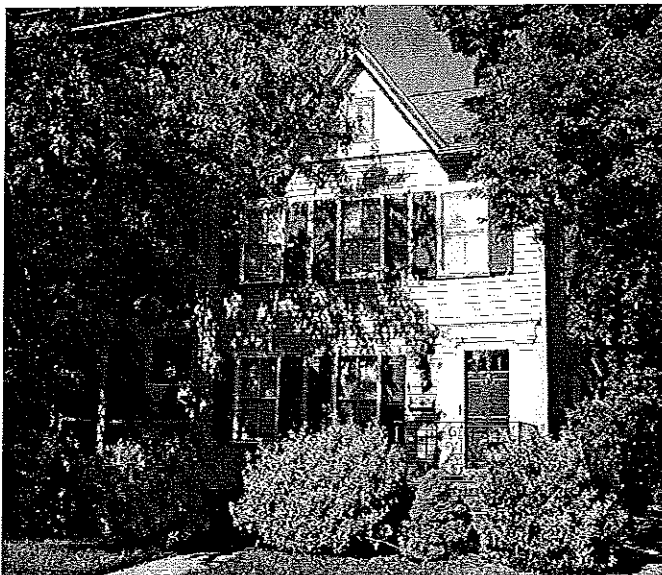
PHOTO Negative File No. 3-15

Colonial Revival doorway enframingent with pilasters and entablature; paneled door with four Gothic-like lights; 2/2 sash windows with louvered shutters; screened porch on SE corner is later addition.

2006 update: Door and frame remains but with a new storm door on outside.

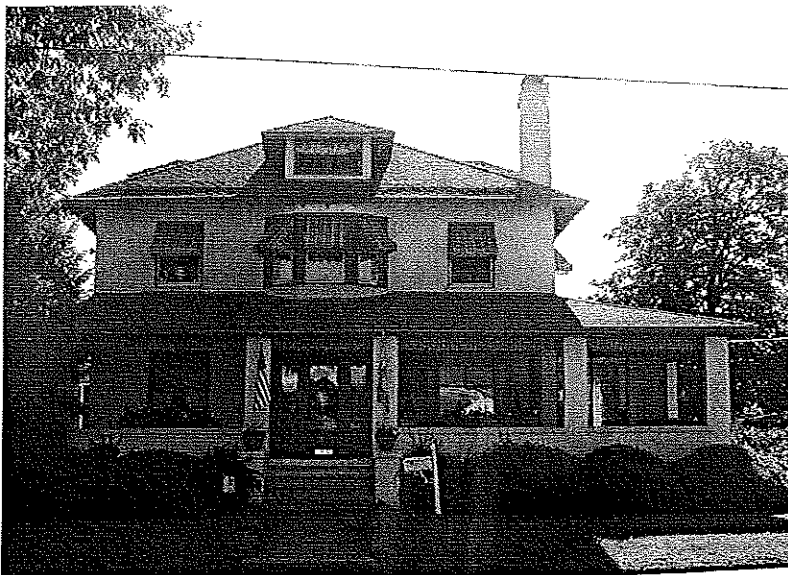
PHOTO Negative File No. 3-12, 13

Mission style elements include the red tile roof with exposed rafter ends and the stucco exterior; large porch on W. and S. sides is partially screened in; projecting vestibule and double doorway; diamond-paned casement window in dormer; large 1/1 sash windows, including tripartite projecting bays. No apparent alterations.

2006 update: Red tile roof gone, now green tar shingles; striped awnings added to windows on 2nd story and porch.

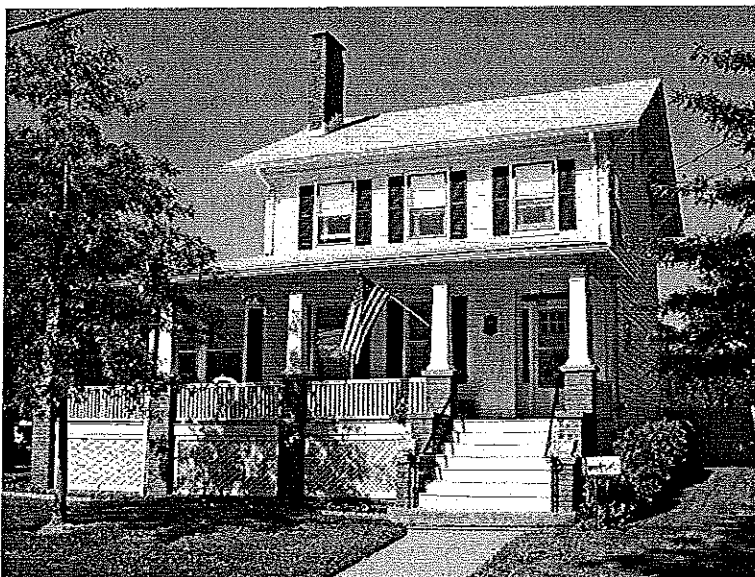
PHOTO Negative File No. 3-14, 8-19

Oversize brackets on eaves and wide overhang; 1/1 sash windows; Colonial Revival door enframement with art glass transom and sidelights; tapered square porch posts with red brick piers.
